# Chip Errata for the i.MX28

This document details all known silicon errata for the i.MX28. [Table 1](#) provides a revision history for this document.

Document Number: IMX28CE

Rev. 3

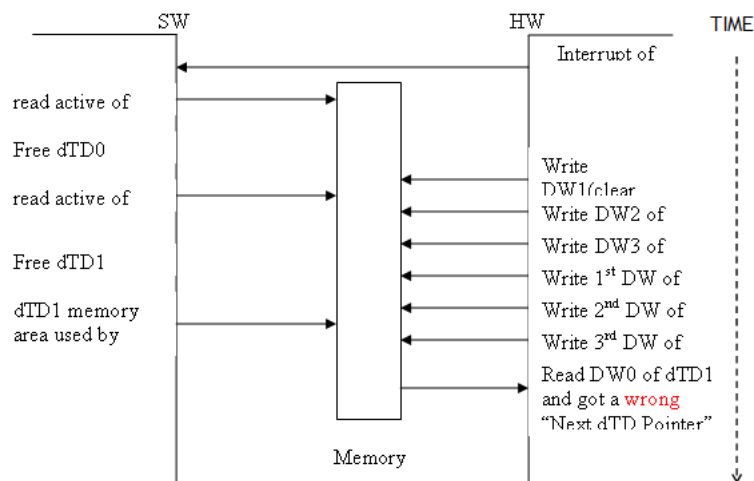
Figure 1. dTD Issue Sequence of Events

After step 1, if software finds the Active bit is cleared, then the dTD memory space is freed and may be allocated for another thread's use. In step 3, hardware may get a wrong dTD.

This issue only occurs when the dTD list is used; because if only one dTD is used, the software only checks the Active bit after an interrupt is received (step 3). However, when the dTD list is used, the software may check the entire list after the interrupt for the first dTD is received, when the hardware has just finished the transfer of the second dTD.

Figure 1 illustrates this issue.

USB Controller may hang if dTD is freed too quickly.

Postpone freeing the current dTD; free it when its next dTD can be freed, so the last completed dTD (followed by an ACTIVE dTD) is always freed when the next IOC irq comes.
